# Certificate of Crash Test according to

## **ISO 10542-1:2012 Wheelchair tiedown and occupant-restraint systems - SWM & ISO 7176-19 – 2008 Wheeled mobility devices for use as seats in motor vehicles**

**Test object/  
Wheelchair:** Scout X10 FWD with Dahl Docking WTORS

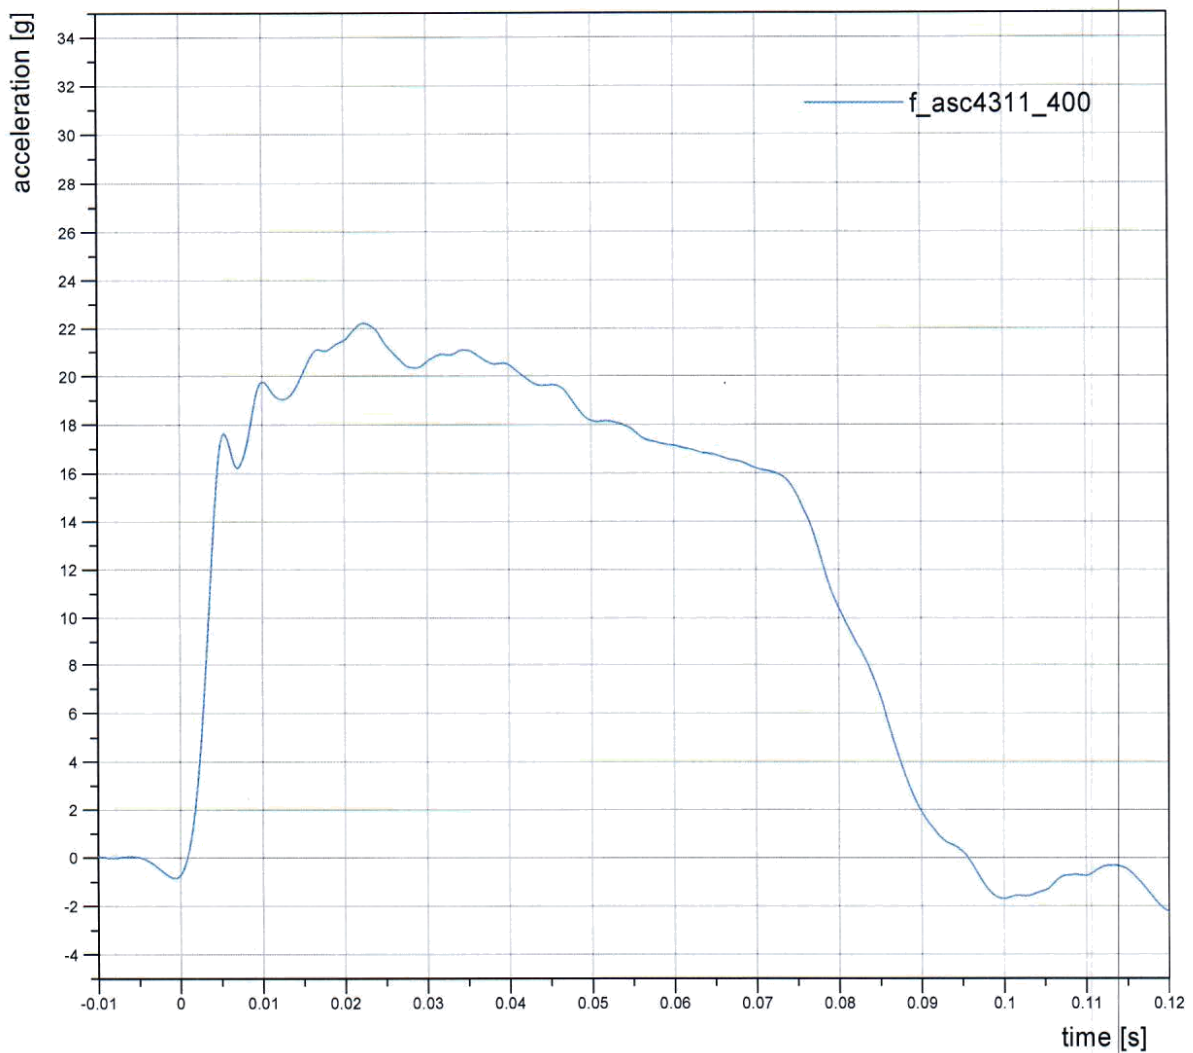
**SLED ACCELERATION**

**Measuring:** The deceleration was measured by accelerometers mounted on the crash test sled.

**Sled deceleration  
and speed:** See page with plotted graph and speed

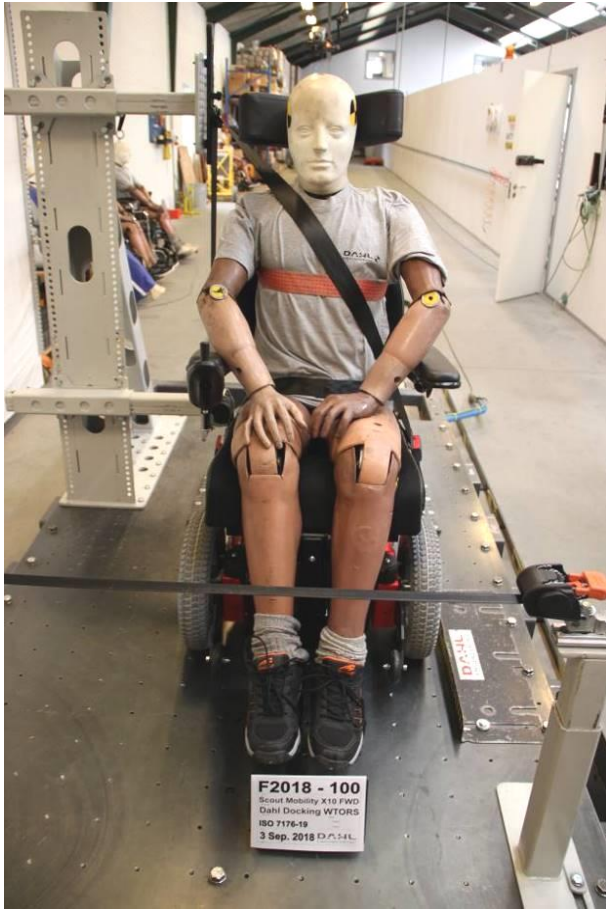
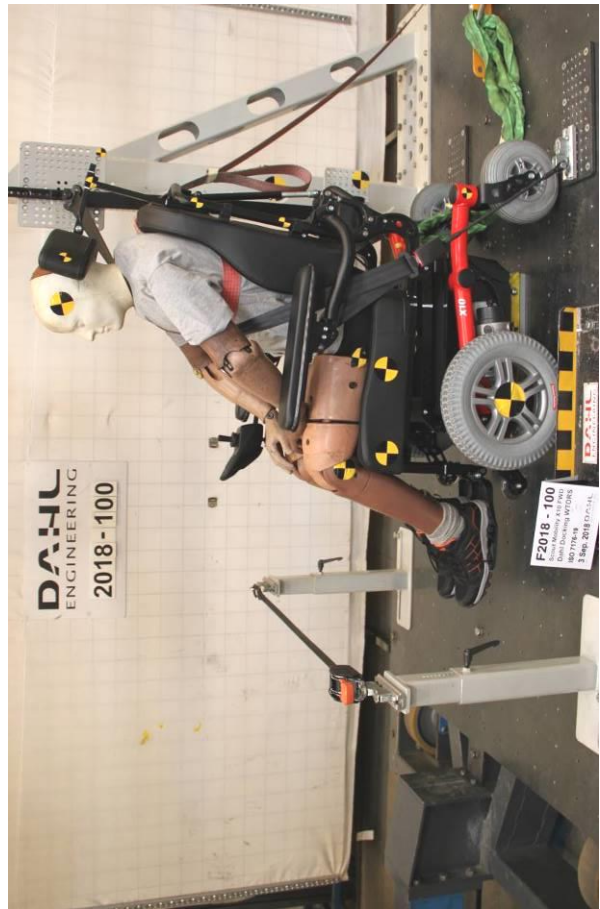
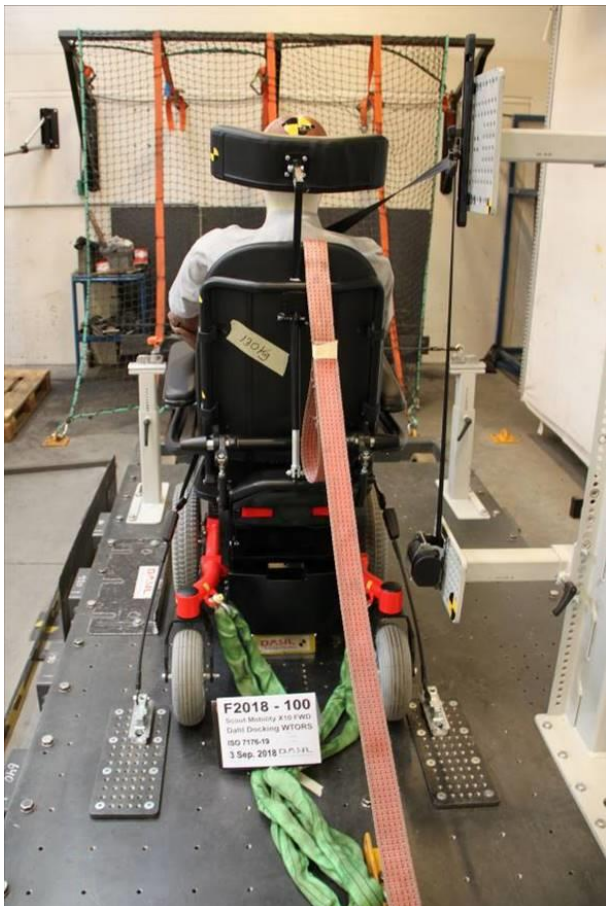
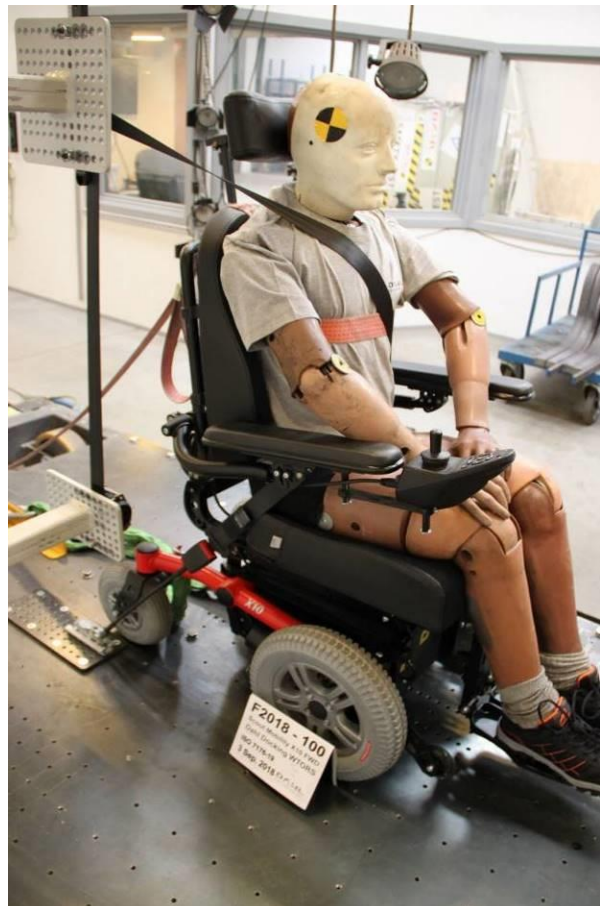
Pre- test photos

**Photography:** The test was filmed with a high speed camera at 500 fps.  
Still pictures, pre and post test, was also taken.

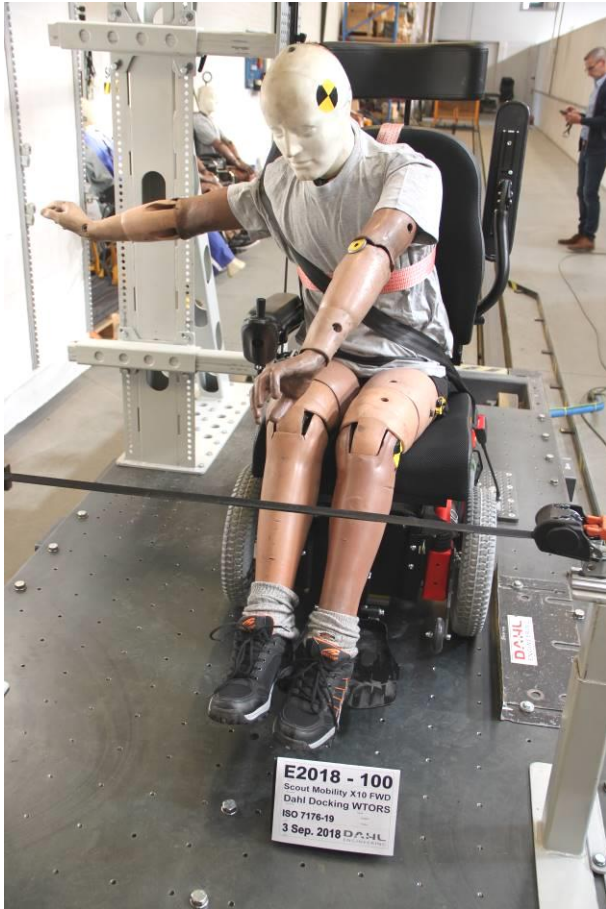
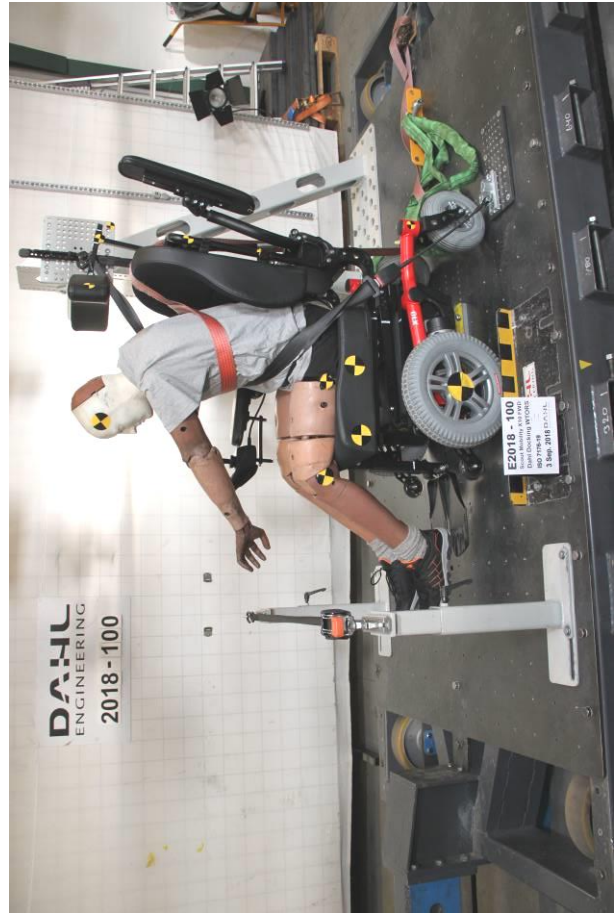
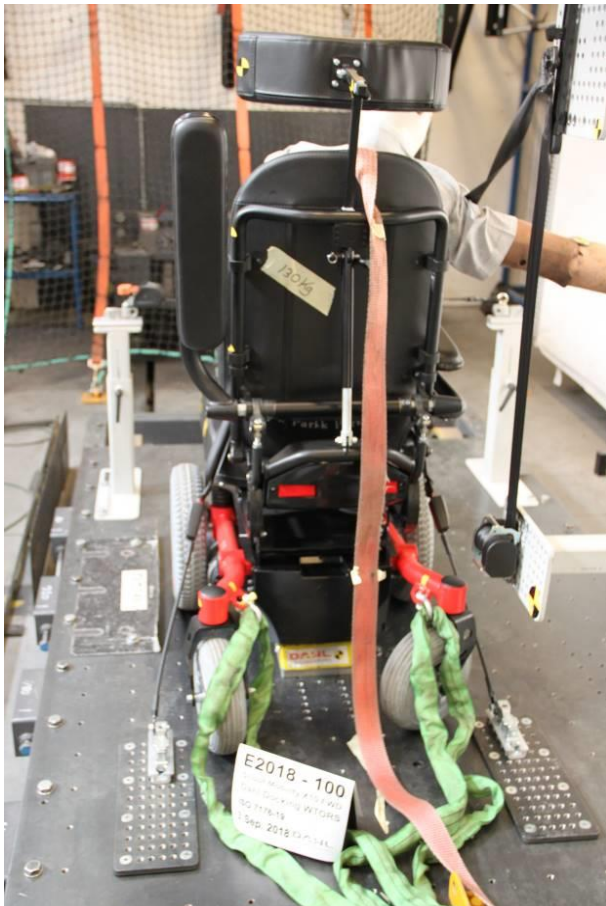
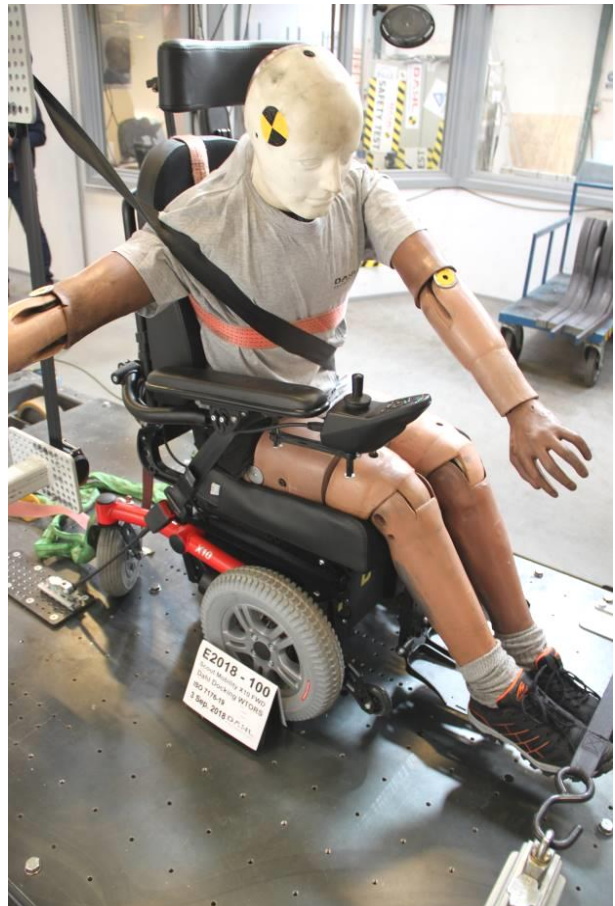
Post test photos

There were no fragmented or separated component, that may contact the occupant, produced with sharp edges less than radius 2 mm	X
	There were no visible signs of failure on the wheelchairs primary load carrying components	X
	There were no visible signs of failure on the wheelchairs seat adjusters	X
	The ADT was removed from the wheelchair without the use of tools	X
	The wheelchair was released from the tie-down system without the use of tools	X
	The post test decrease of the mean H-point height is not more than 20%	X
