Certificate of Crash Test according to

ISO 10542-1:2012 Wheelchair tiedown and occupant-restraint systems - SWM & ISO 7176-19 – 2008 Wheeled mobility devices for use as seats in motor vehicles

**Test object/
Wheelchair:** Scout X10 MWD with Dahl Docking WTORS

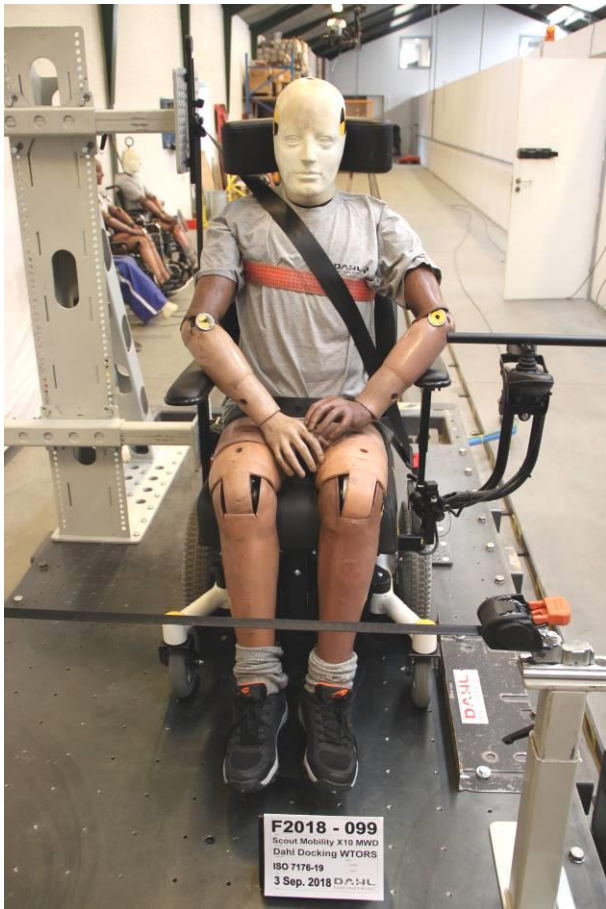
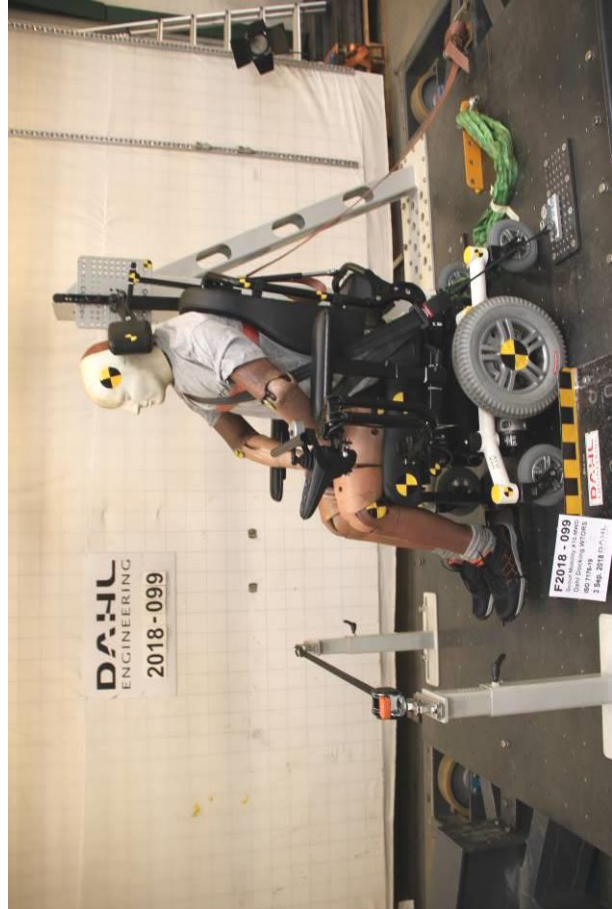
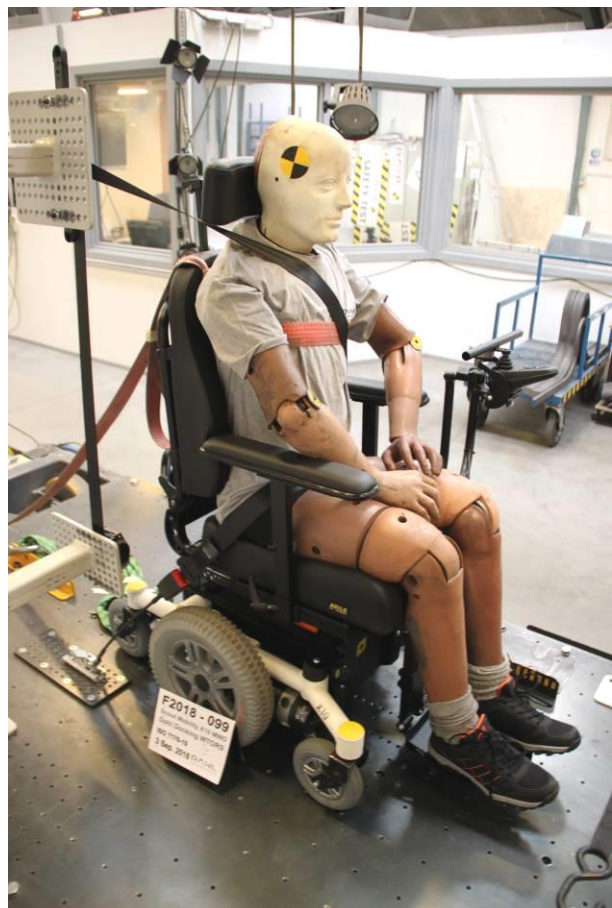
Pre- test photos

Photography: The test was filmed with a high speed camera at 500 fps.
Still pictures, pre and post test, was also taken.
