# Certificate of Crash Test according to

## **ISO 10542-1:2012 Wheelchair tiedown and occupant-restraint systems - SWM & ISO 7176-19 – 2008 Wheeled mobility devices for use as seats in motor vehicles**

**Test object/  
Wheelchair:** Scout X10 RWD with Dahl Docking WTORS

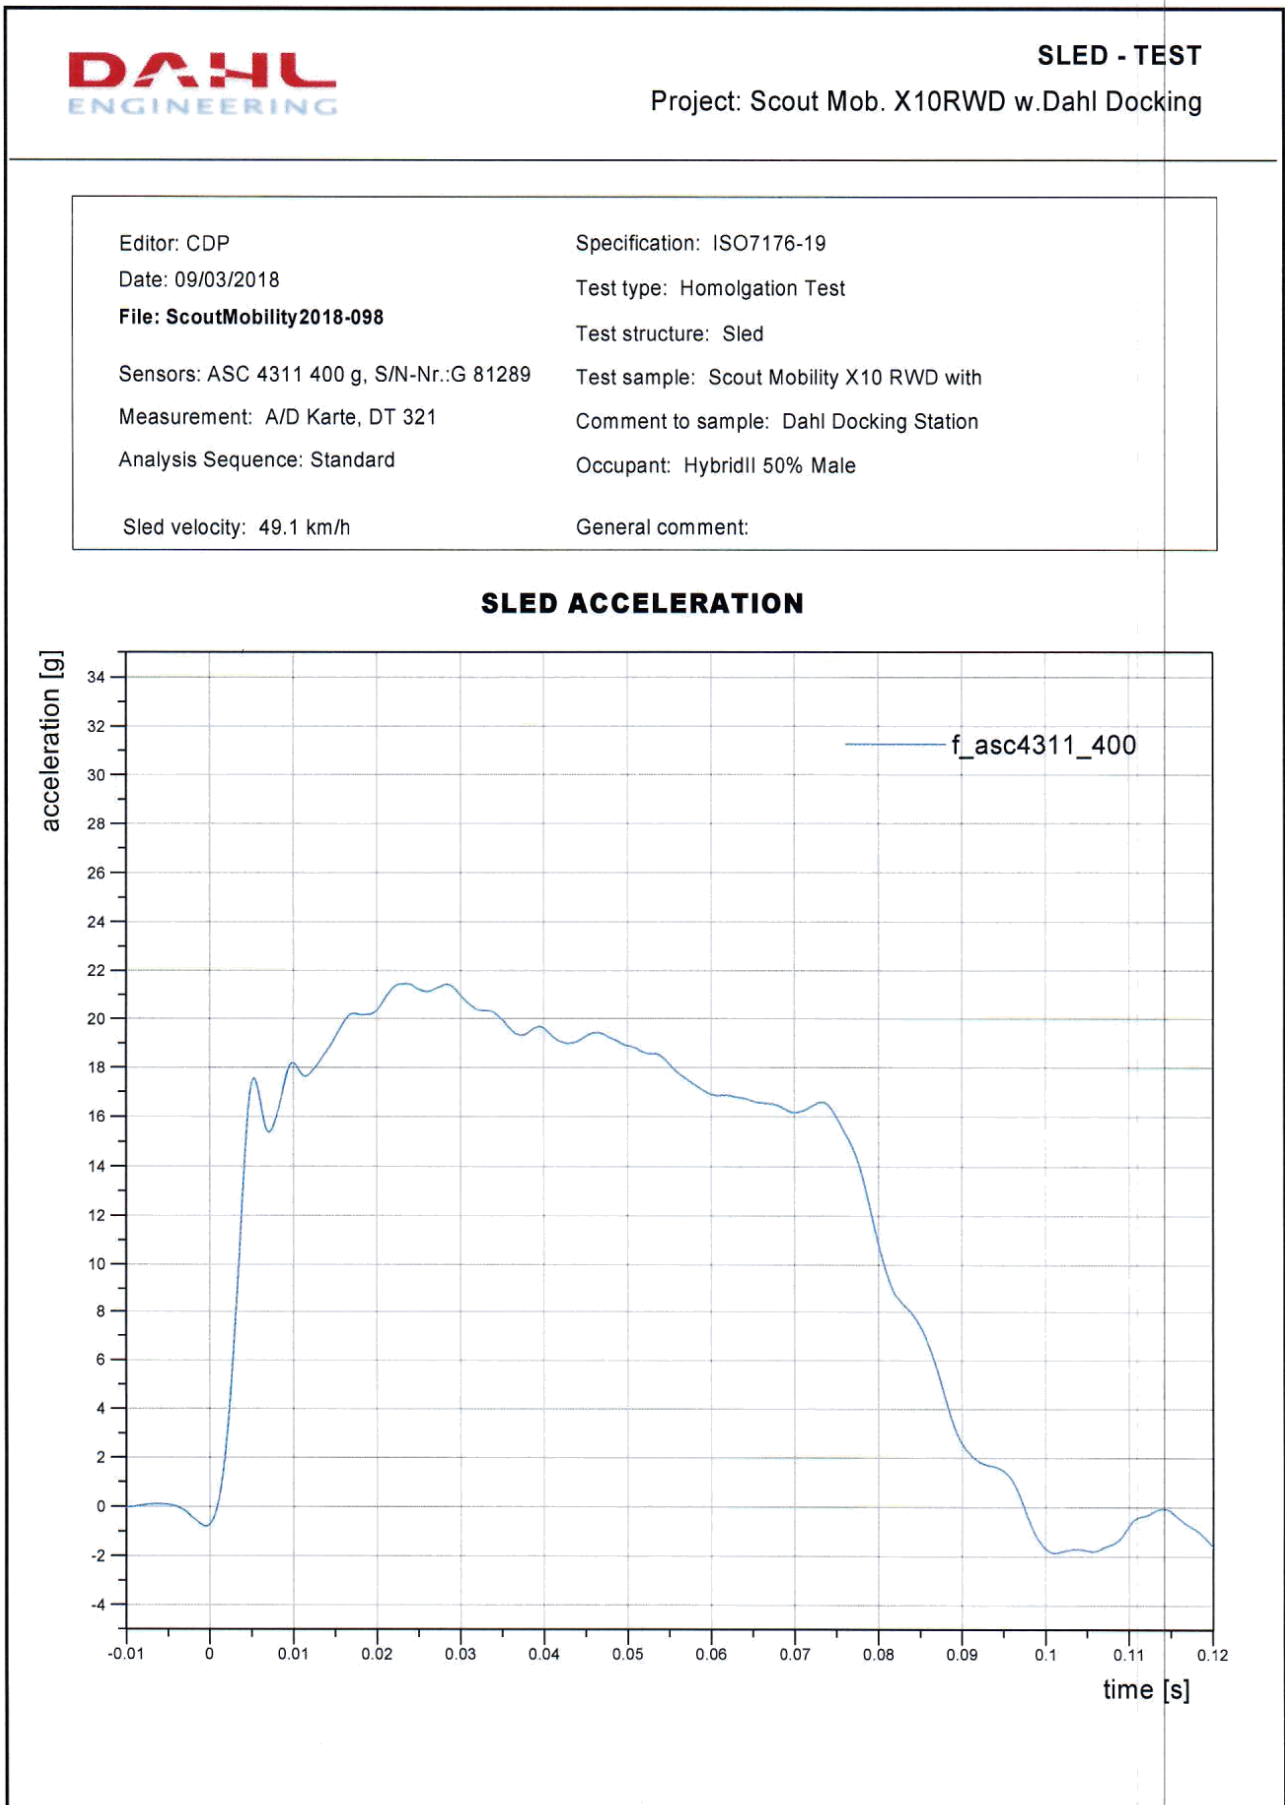
Plotted graph and speed

**Measuring:** The deceleration was measured by accelerometers mounted on the crash test sled.

**Sled deceleration****and speed:**

See page with plotted graph and speed

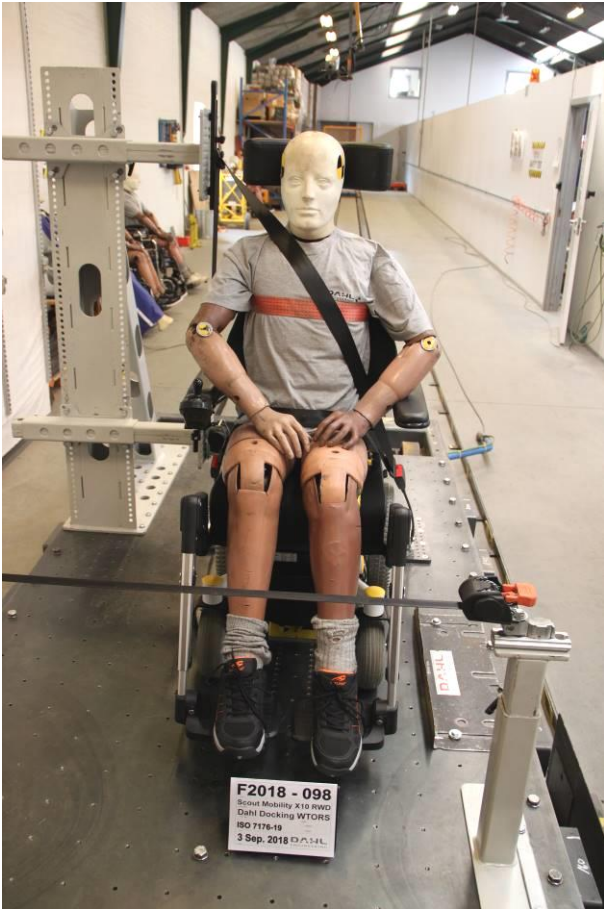
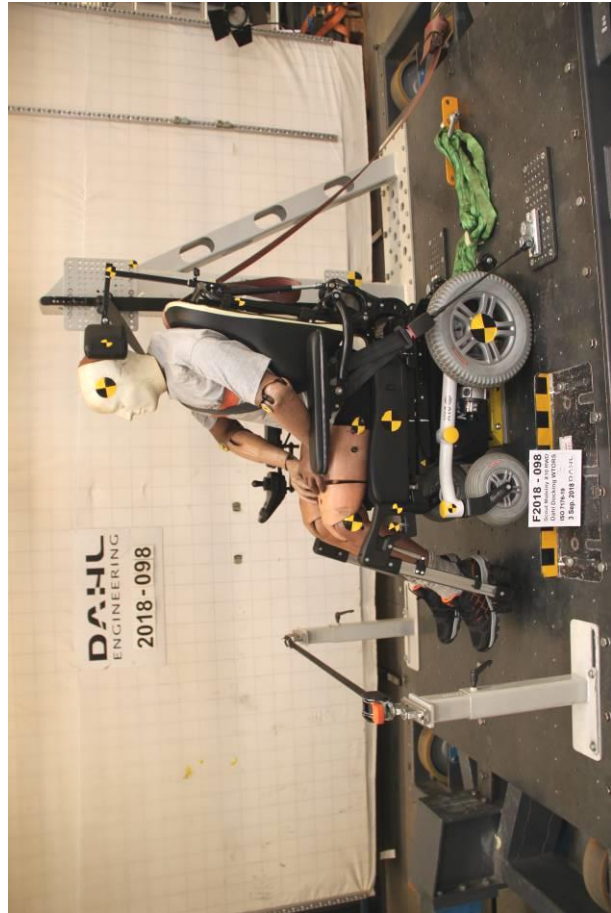
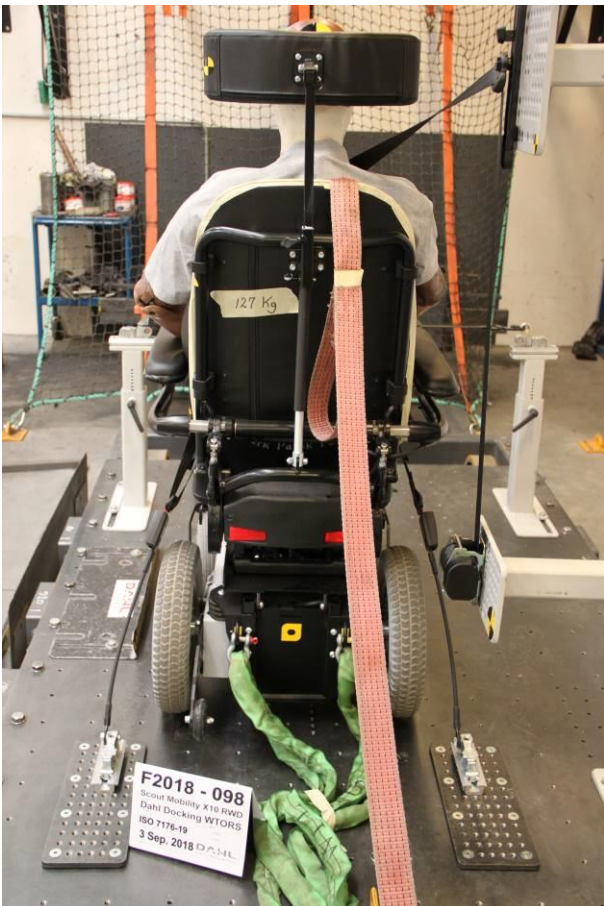
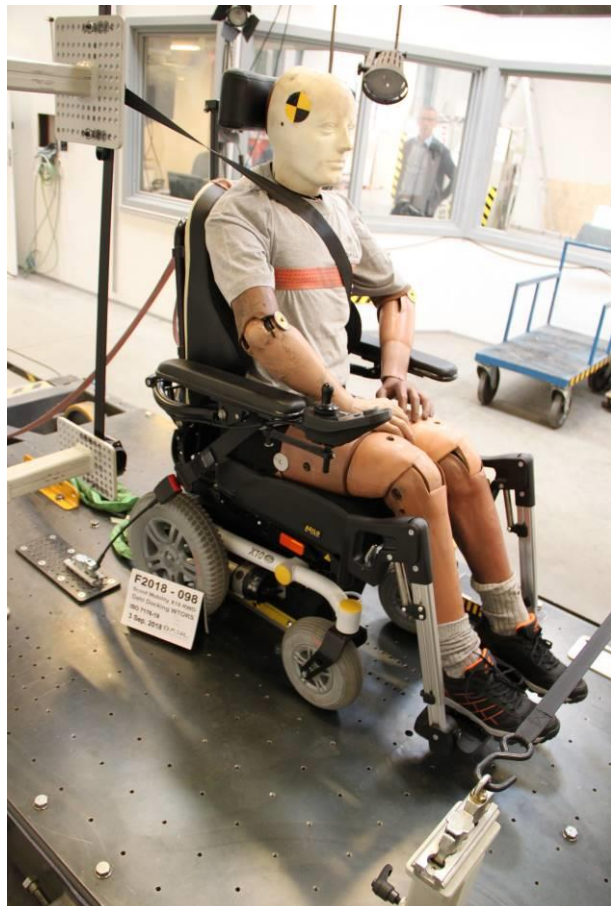
Pre- test photos

**Photography:** The test was filmed with a high speed camera at 500 fps.  
Still pictures, pre and post test, was also taken.

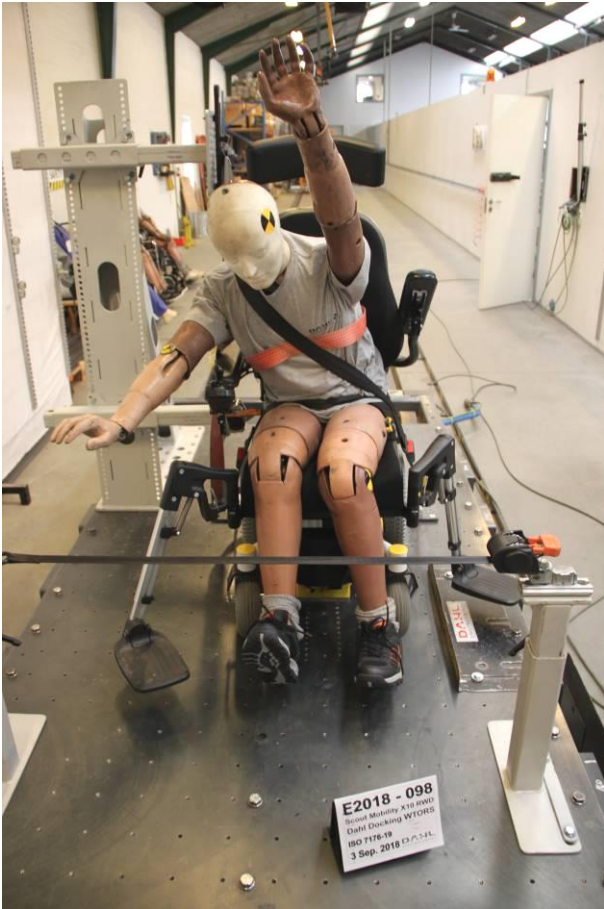
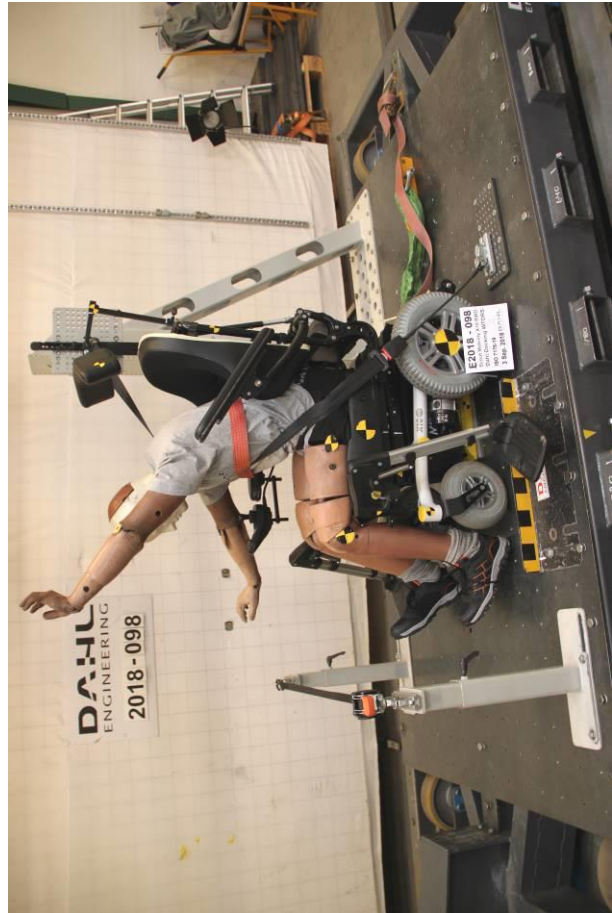
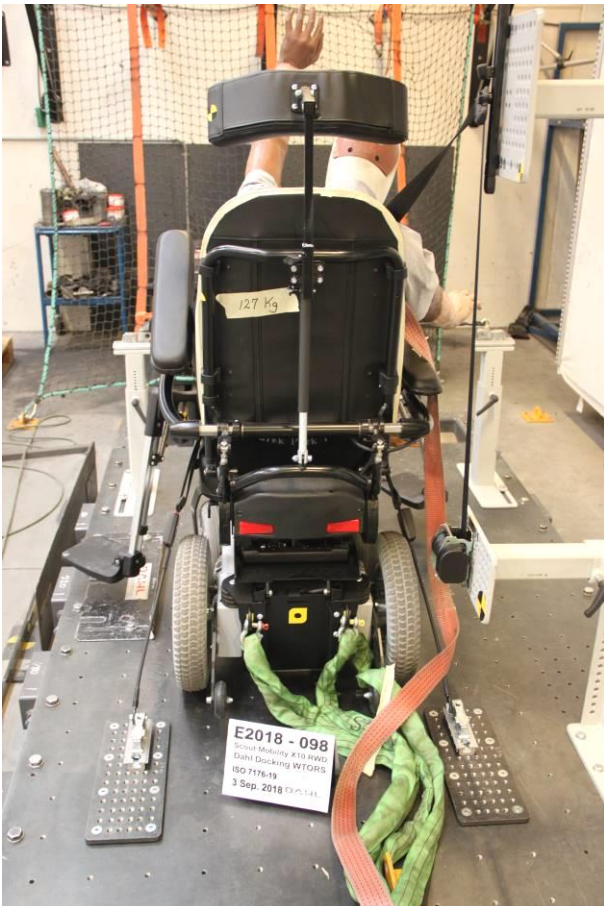
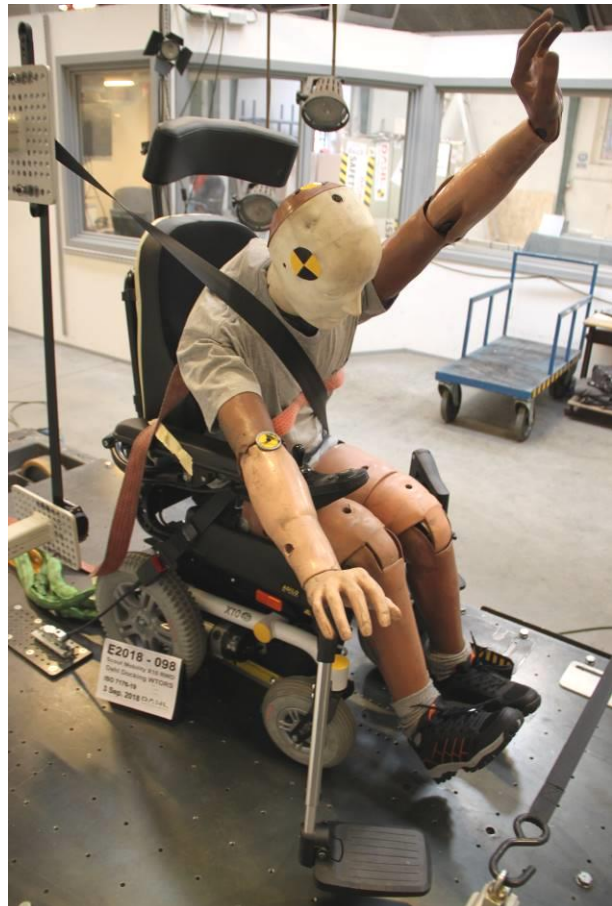
Post test photos

There were no fragmented or separated component, that may contact the occupant, produced with sharp edges less than radius 2 mm	X
	There were no visible signs of failure on the wheelchairs primary load carrying components	X
	There were no visible signs of failure on the wheelchairs seat adjusters	X
	The ADT was removed from the wheelchair without the use of tools	X
	The wheelchair was released from the tie-down system without the use of tools	X
	The post test decrease of the mean H-point height is not more than 20%	X
